WHITE STRUCTURE FLAKING IN ROLLING BEARINGS FOR WIND TURBINE GEARBOXES

By Hideyuki Uyama and Hiroki Yamada, NSK Ltd.

An investigation into the failure modes yielding white structure flaking and axial cracking in wind turbine gearbox rolling bearings

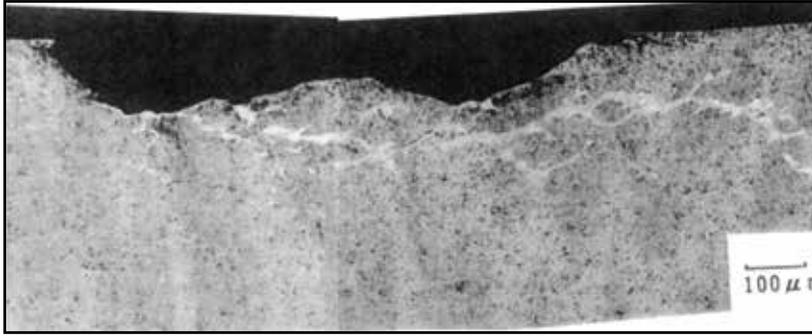
Figure 1: An example of the cross section of white structure flaking in an automotive electrical accessory bearing [3]

flaking area at the dotted line in Figure 2a. A microstructural change called white structure was observed at the flaking. Flaking morphology of failed bearings in wind turbine gearbox and automotive electrical accessories seem to be very similar as shown in Figure 1 and Figure 2b although bearing types and size are quite

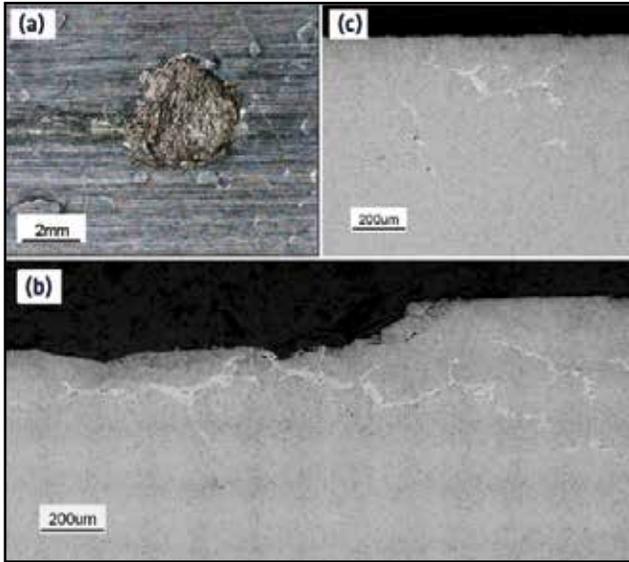
Figure 2 shows the observation results of a failed cylindrical roller bearing, which were used on the high speed shaft in wind turbine gearboxes. A small flaking was seen in the raceway surface as shown in Figure 2a. Figure 2b shows the cross section of the

different. Namely, small size ball bearings are used for automotive electrical accessory and large size roller bearings are used for wind turbine gearboxes. Figure 2c shows the cross section of an area without flaking in the same bearing as shown in Figures 2a and 2b. White structure was observed even in this area, which is

most likely to be the prior stage to flaking. Therefore it is presumed that this type of flaking in wind turbine gearboxes is initiated at the white structure.

Figure 2: The raceway and the cross section of a failed bearing with white structure. a) Raceway surface of flaking area b) Cross section of the dotted line in Figure 2a c) Cross section of no flaking area

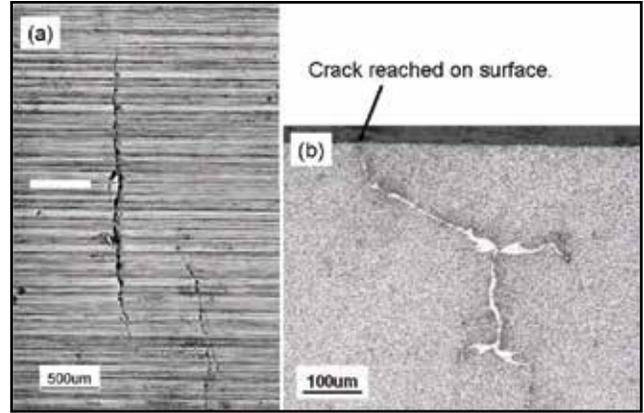
Figure 3 shows the observation results of the other failed bearing, which is also a cylindrical roller bearing and used on the high speed shaft in wind turbine gearboxes. There were several large cracks longer than 10 mm and many small cracks around 1-3 mm in the axial direction on the raceway surface of the inner ring. Figure 3a shows two small cracks chosen of many axial cracks, which were observed on the raceway surface. The small cracks seem to be an early stage of crack propagation. A small axial crack was chosen for the cross section observation because small cracks

are easier than large cracks to find the location of the crack initiation. Figure 3b shows the cross section including the small axial crack area. White structure was seen

and it is seemed that a crack propagated along the white structure and reached the raceway surface. This crack is seen as the axial crack on the raceway surface.

Figure 3: The raceway surface and the cross section of a failed bearing with axial cracks. a) Axial cracks on the raceway surface b) The cross section through the cracks

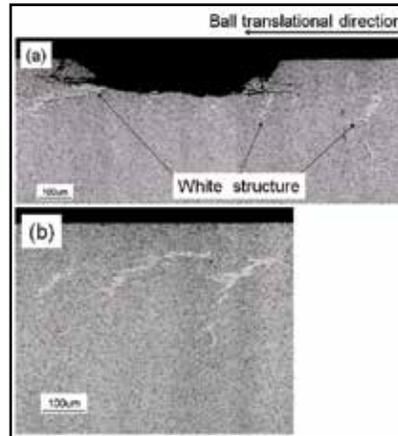
Figure 6a shows the microstructure of the flaking cross section in the hydrogen-charged specimen. White structure was observed around the flaking area. White structure was observed also in the cross section of an area without flaking as shown in Figure 6b. Therefore, it is presumed that this flaking was initiated from white structure formed subsurface. On the other hand, flaking did not occur

Figure 6: The cross section of hydrogen-charged specimen a) Flaking area b) No flaking area

cur and the tests were suspended in the uncharged specimen. There was no microstructural change in the uncharged specimen. Therefore, it is presumed that hydrogen induced microstructural change and decreased rolling contact fatigue life.

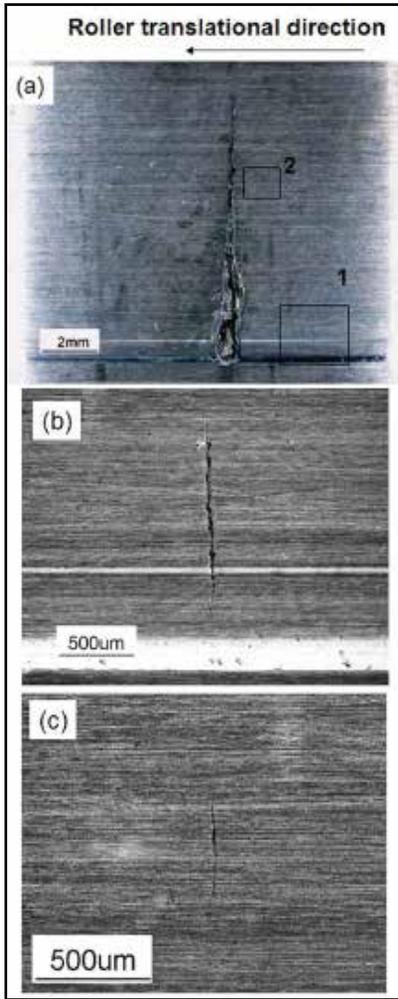
Figure 8: The raceway surface of the hydrogen-charged outer ring a) Large axial crack b) Magnification of position 1 in Figure 8a c) Magnification of position 2

Figure 8 shows the outer ring raceway surface which was charged with hydrogen. One large crack and two small cracks were observed. These cracks propagated straight in the axial direction and were identical to the axial cracks in the failed bearings of wind turbine gearboxes.

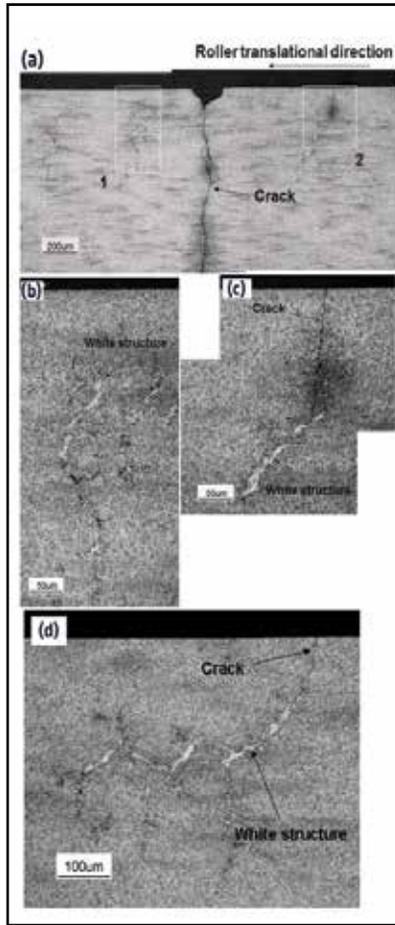
Figure 9: The cross section of the cracked area of a hydrogen-charged outer ring a) The cross section of position 2 in Figure 8a; b) Magnification of position 1 in Figure 9a; c) Magnification of position 2 in Figure 9a; d) The cross section of the small crack in Figure 8b

Figure 9a shows the cross sections of the cracking area including the position 2 in Figure 8a. The large crack propagated in the depth direction. White structure was observed independently in Figure 9a position 1 to the left of the large crack magnified in Figure 9b. And also, Figure 9c is the magnification of the position 2 in Figure 9a and including the small axial crack

in Figure 8c. The small crack connected with white structure. Therefore it is supposed that white structure was formed first such as in Figure 9b and then a small crack initiated from the white structure and propagated to the raceway surface such as Figure 9c and finally the crack propagated in the axial and depth directions such as is visible in Figure 8a and Figure 9a. Figure 9d shows the cross section including the small axial crack in Figure 8b. White structure was observed also in this area and it seems that the crack initiated at the white structure and propagated to the surface.

However, white structure was not observed on the cross section of the large axial cracks. This reason is supposed that the initiation of the large axial crack would be white structure, but it is difficult to observe the cross section pinpointing the crack initiation. It is much easier to observe the cross
