# WIND TURBINE DFIG GENERATOR SLIP RING DEFECT

*This case study shows how, in time, detection of slip ring defects could result in fast and non-expensive repairs.*

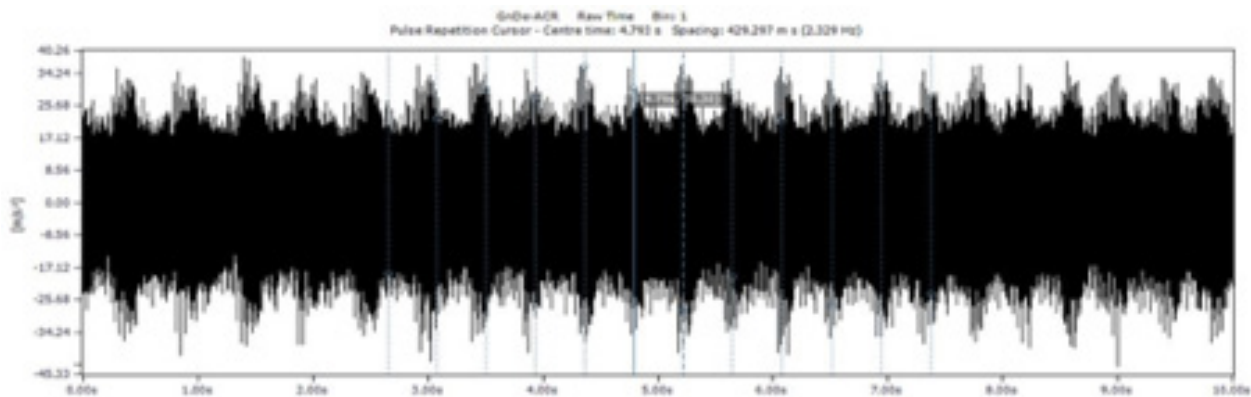
A detailed time waveform and frequency spectrum were looked at shortly after start-up, as shown in Figures 2-3.

The increased vibration levels related to generator rotor dynamics indicated a potential problem with generator slip ring unit. An alarm report was issued immediately followed by a phone conversation with the site manager, explaining the problem. Below are some extractions from the recommendation section of the report on the assessment of maintenance needs:

Figure 2: The time waveform showing amplitude modulation of a little less than 2.5 Hz.

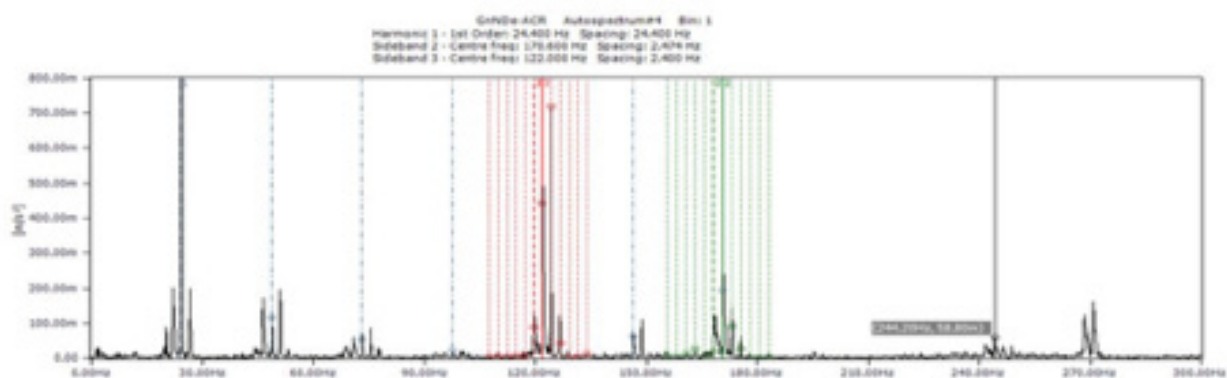
Figure 3: Increased vibration amplitude for several harmonics as measured by the accelerometer located on the non-driven end generator bearing.

- Generator inspection is recommended within 1-2 weeks.
- It is recommended to perform an up-tower generator

test run with particular focus on the slip ring unit. Check the height of the slip ring brushes to be within the acceptable limits, inspect the condition of the cooling grooves, insulation ring, and the current clamps.

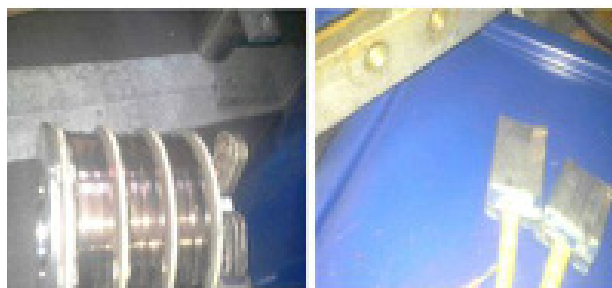
After confirming that the slip ring unit and brushes were damaged, these were quickly replaced, and the wind turbine was put back into operation. As seen in Figure 5, the vibration on the generator bearings were lower.

Figure 4: Slip ring shown with worn out cooling grooves (left), and worn out brushes (right).

► **Slip ring unit replacement:** Approximately 4,000 euros plus a few hours downtime (500-1,000 euros).

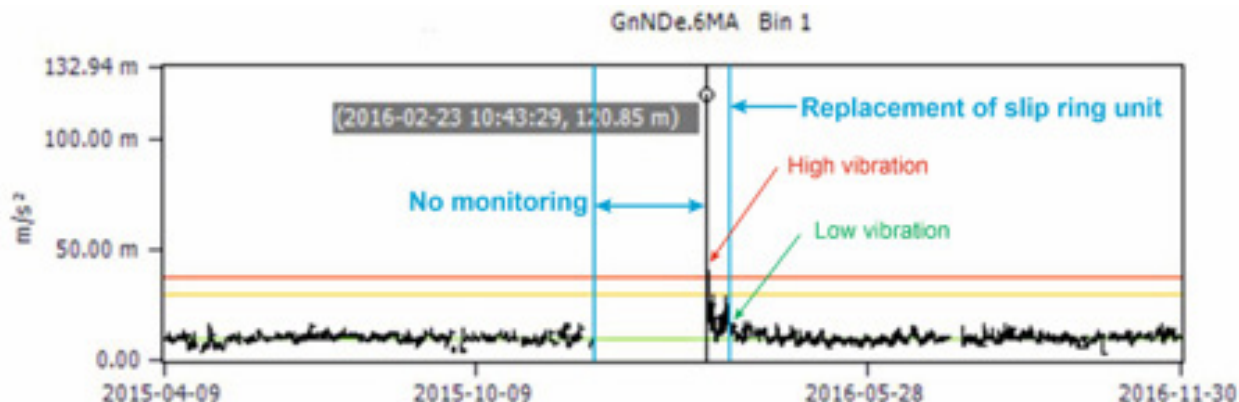
Figure 5: Vibration amplitudes returned to normal (6x harmonic shown), as measured by the accelerometer located on the non-driven end generator bearing.
