SEVEN YEARS OF SOLID RESULTS

Field testing confirms the long-life potential for Timken™ wear-resistant mainshaft bearings in wind turbines.

By CALEB CHOVAN

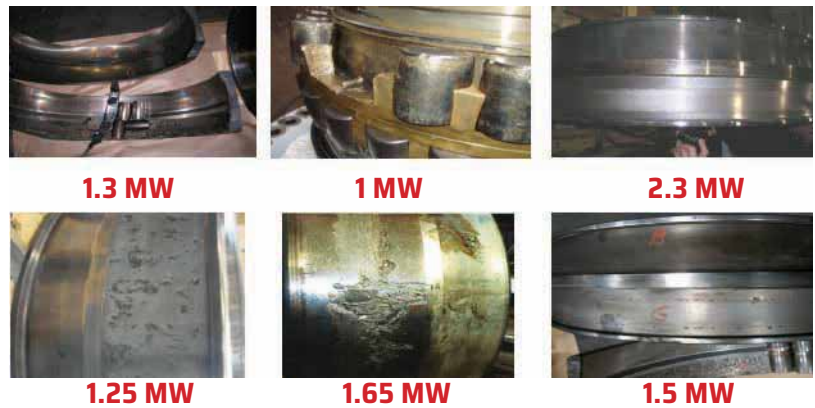
COMMON DAMAGE ON 3-POINT MOUNT SRB MS BEARING

Table 2: Adhesive damage is common in standard mainshaft spherical roller bearings with most of the loading occurring on the downwind side of the bearing. (Courtesy: Timken)

Naturally, the size of the bearing and the power of the turbine will also factor into the amount of bearing damage experienced. Despite this, Timken scientists have observed similar damage patterns in different turbine models over the years, given most mainshaft bearings experience high loading and repeated metal-to-metal contact. This adhesive wear can be seen in Table 2 in various non-coated spherical roller bearings (note the upwind side of the bearing will typically experience less damage).

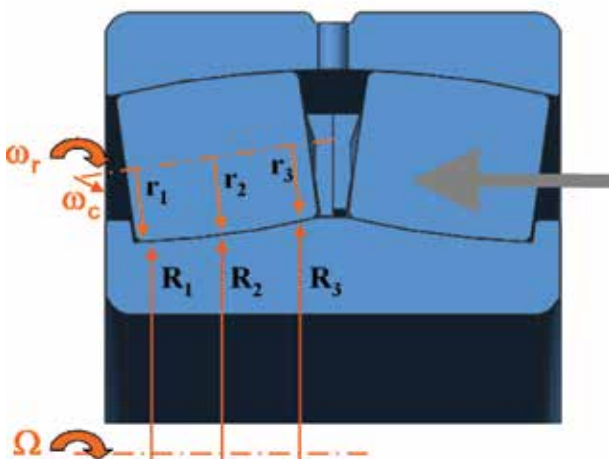
Rollers will slide on the downwind row raceway in mainshaft spherical roller bearings due to a phenomenon called Heathcoat slip. Heathcoat slip is a geometrical constraint suffered by spherical roller bearings. As illustrated in Figure 1, if surface velocities between the inner ring and the rollers match at locations 1 and 3, then the surface velocities must differ at location 2, which means that there is sliding between the roller and the center of the raceway. Specifically, the inner raceway will have a slower velocity, making the risk of micropitting extremely high for the downwind row.

Figure 1: Physical description of the source of Heathcoat slip in a spherical roller bearing. (Courtesy: Timken)

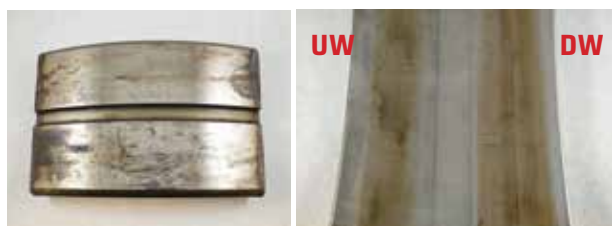
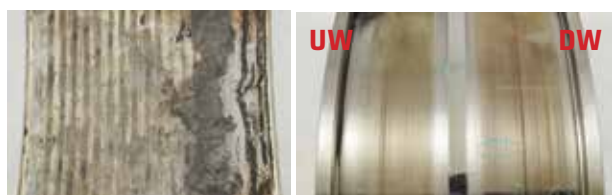
Figure 2: Outer and inner ring inspection showed visible grind lines indicating limited adhesive wear. (Courtesy: Timken)

- **Inspection of the bearing outer and inner ring** revealed light-to-moderate fretting wear on the outer ring O.D. while the outer race was noted to be in “good” condition (as evidenced by visible grind lines, where a standard mainshaft spherical roller bearing would likely not exhibit grind lines at the same stage of operation). Minor debris denting and lubrication staining (the source of the discoloration in Figure 2) was also observed on the outer race. On the inner ring bore (the surface that contacts the mainshaft), some fretting wear was visible, while the inner raceway, noted to be in “good” condition, showed only minor discoloration and debris denting (possibly due to handling and removal).

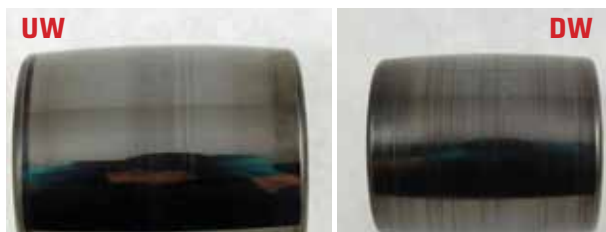
ROLLERS

Figure 3: Both roller complements were in “very good” condition after operation and maintained their original profile. (Courtesy: Timken)

- **Bearing roller inspection** (Figure 3) showed that both roller complements were in “very good” condition, with the upwind roller complement exhibiting only minimal distress and light circumferential lining, while the downwind roller complement exhibited light circumferential lining and debris dents.

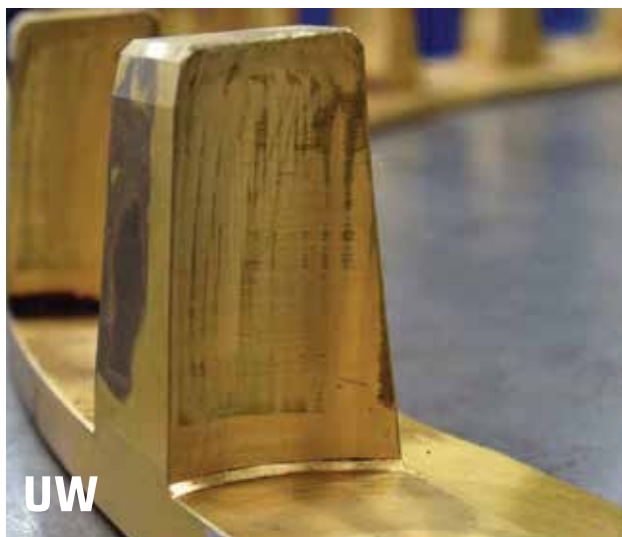
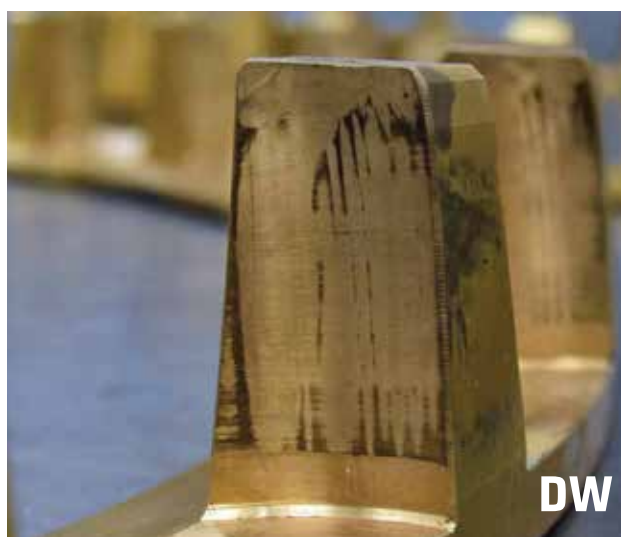
CAGE

- **Brass cage inspection** (Figure 4) revealed the cage bridges showed only minor discoloration in the pockets (most likely from the grease) and the complete cage was noted to be in “very good” condition.

Figure 4: Brass cages offer extra strength in the toughest applications; no cage damage, and only minor discoloration, was observed in the 230/600-series Timken bearing. (Courtesy: Timken)
