During annual inspections, it's of paramount importance to inspect foundations every year for cracks as an integral part of proper turbine maintenance.

By JOSEPH W. BRUCE

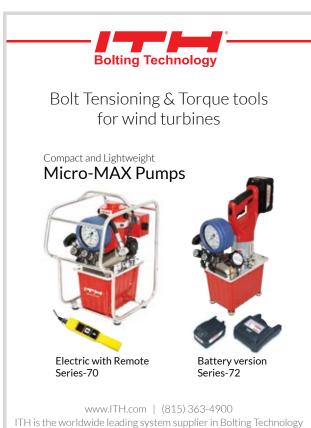
Workers mark and tension foundation anchor bolts.

Unfortunately, foundation anchor bolts lose tension over time. Think of them as guitar strings. If the strings do not have the proper tension, the guitar does not perform the way it was meant to. It's the same with foundation anchor bolts. The foundation loads become out of balance, and fatigue within the foundation can bring expensive and potentially catastrophic results. Most of the relaxation in the rods and creep in the foundation occur early in the life of

the foundation. For that reason, it is important to perform a full re-tension after 500 hours of initial operation. After that, many operators perform full re-tensions every five years. However, it is recommended, and often required by the design engineer, to do a tension test every other year to monitor the tension. Normally, 10 percent of the foundation anchor bolts are tested at random for correct tension, both inside the tower and outside. To perform this test, the bolt is tensioned at a predetermined level, generally 10 percent below initial tension. If the nut rotates at all or lifts off of the flange as measured by a feeler gauge, it fails, and all of the bolts on that foundation should be re-tensioned.
