A SAFER WAY TO LOOK INSIDE THE BLADE

Internal wind-turbine blade inspection using an innovative drone technology can cut inspection time in half, allowing 40 percent more of the blade to be inspected.

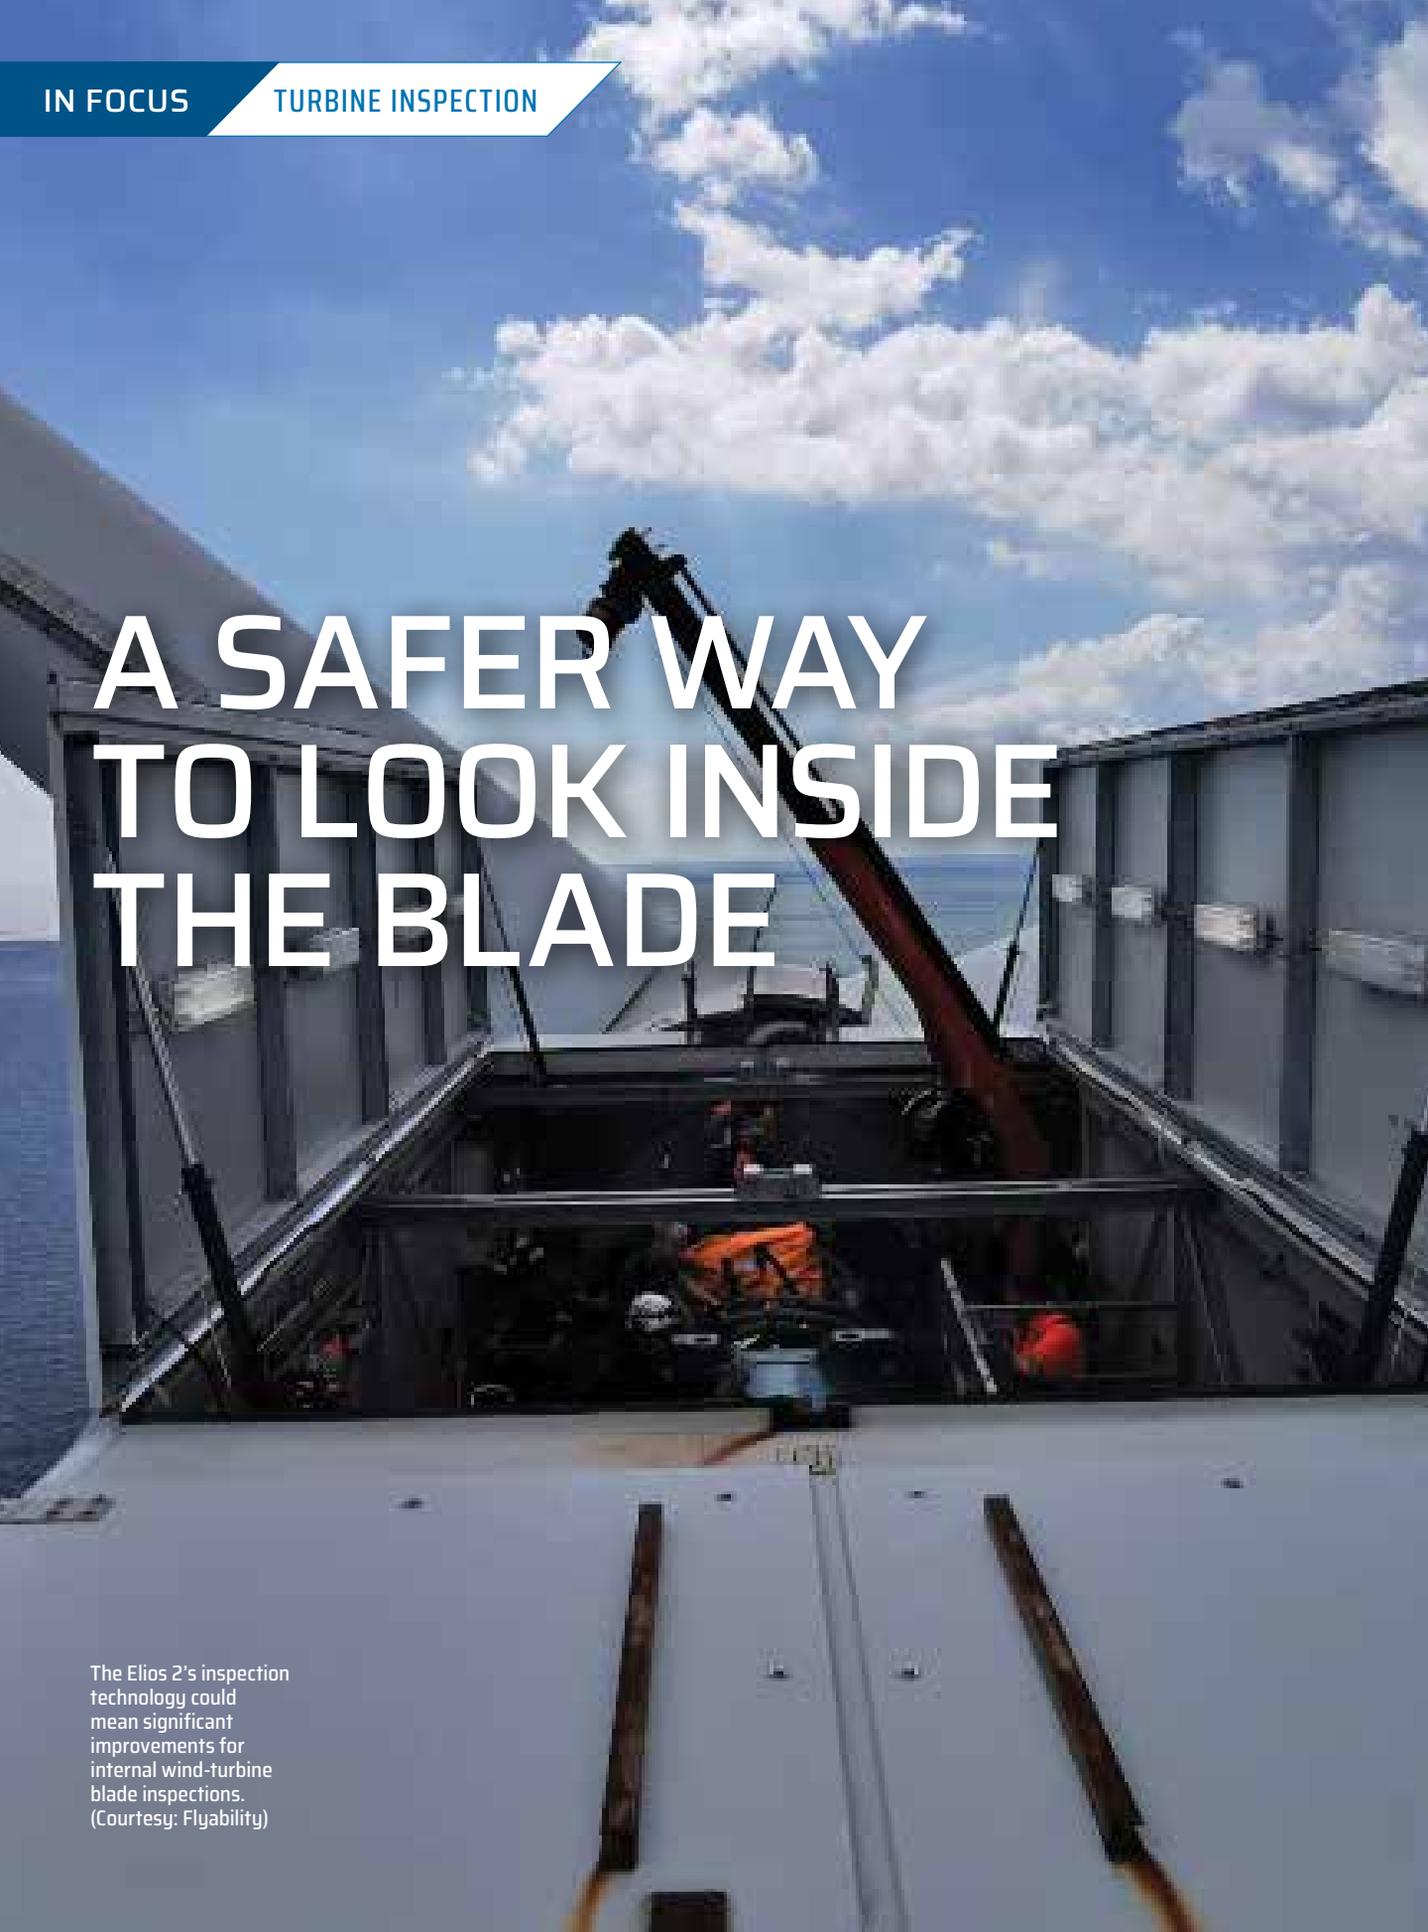
The Elios 2's inspection technology could mean significant improvements for internal wind-turbine blade inspections. (Courtesy: Flyability)

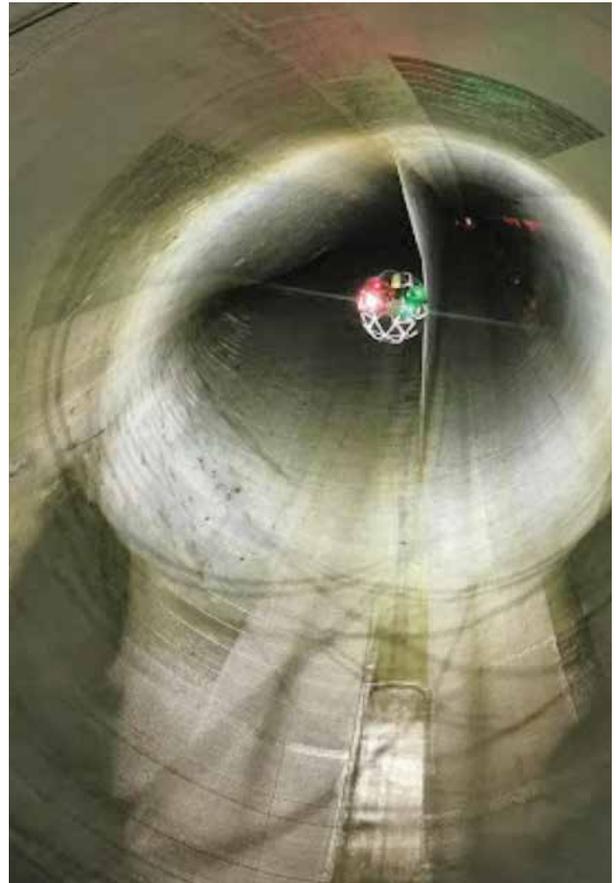
The UNISET is a device that makes it possible for inspectors to know the exact distance the drone is from it when flying into the blades. (Courtesy: Flyability)

The UNISET is a device that makes it possible for inspectors to know the exact distance the drone is from it when flying into the blades, which then allows them to determine the precise location of any defects found during the flight.

▀ **UNISET payload:** Whether the Elios 2 could hold the UNISET device to allow inspectors to get highly accurate locational and distance data for pinpointing where specific images were captured within the turbine.

► **Finding #4 — UNISSET payload:** The Elios 2 carried the UNISSET device just fine, and inspectors were able to use the data it collected to determine the exact location of damage found within the turbines. This information could then be sent to technicians for evaluation and repair, as needed.

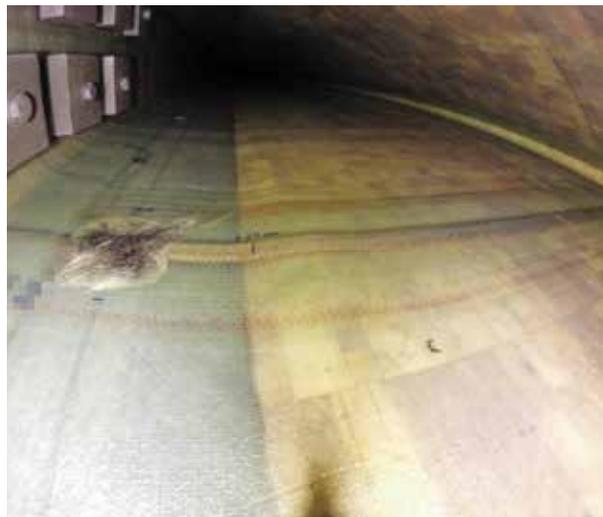
Both sides of the blade — or each chamber — must be inspected in order to identify damage from lightning. (Courtesy: Flyability)

Each blade has two or more chambers separated by a web. The surface of the blade within these chambers is made of a strong compound of laminated materials glued together, which can present a reflective surface.

Both sides of the blade—or each chamber—must be inspected in order to identify damage from lightning, missing bolts, cracks, or other defects that could compromise the blade's integrity.
