KEEPING TABS ON THE TRANSFORMER

A reliable condition monitoring system can ensure that the electrical bushings – which are at a high risk of exposure – and other key elements are closely watched to avoid the sudden failure of the transformer.

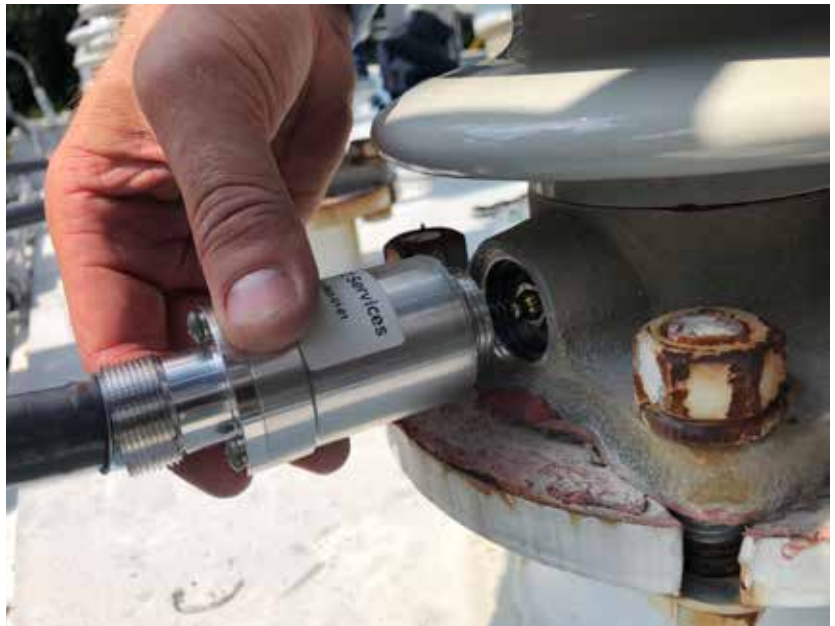
Precision engineered bushing sensors replace the grounding cover at the bushing base. (Courtesy: ZTZ Services International)

A bushing monitor will include a sensor that replaces the C1 test tap grounding cover. Each sensor maintains the ground but also provides very accurate measurement of the small AC leakage current and its phase angle.

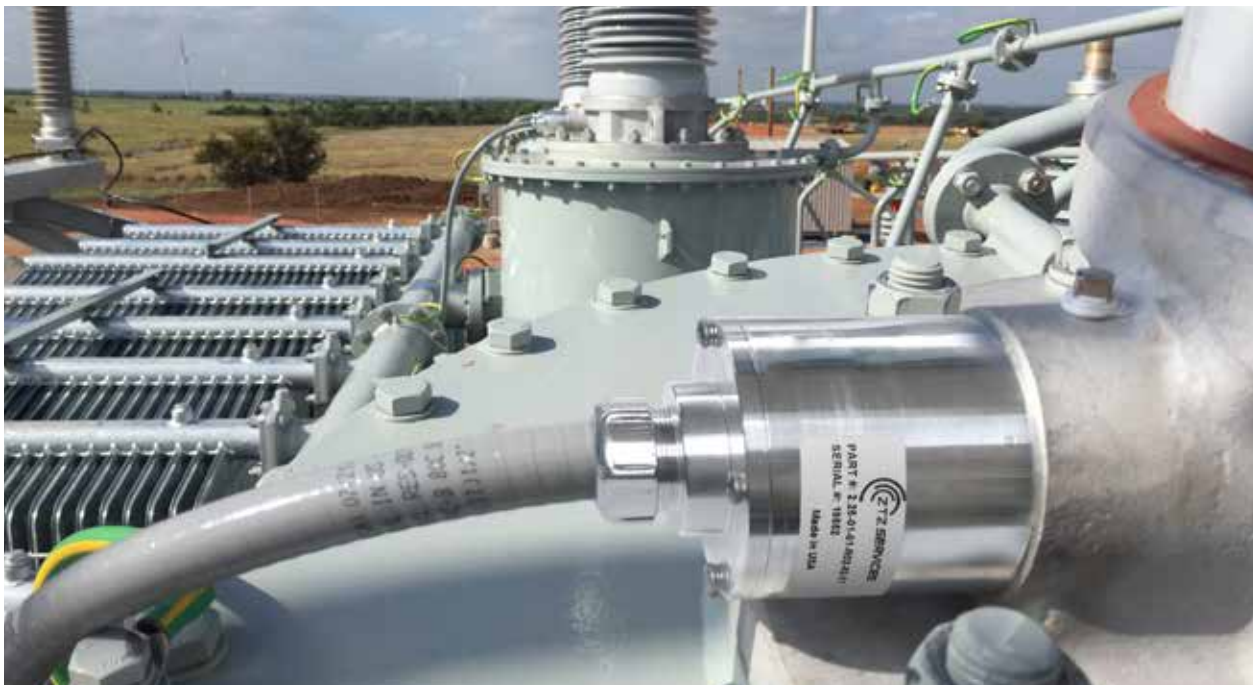
Three bushing sensors on the main step up transformer at Walla Walla Washington NextEra Site. (Courtesy: ZTZ Services International)

For most main step-up applications, both the high-side and low-side bushings are monitored for a total of six

sensors. Installing the sensors requires a brief transformer outage of four hours to install the conduit runs, the sensors, and marshal the cables into the monitor control box. The system is then configured and started when the transformer is re-energized.

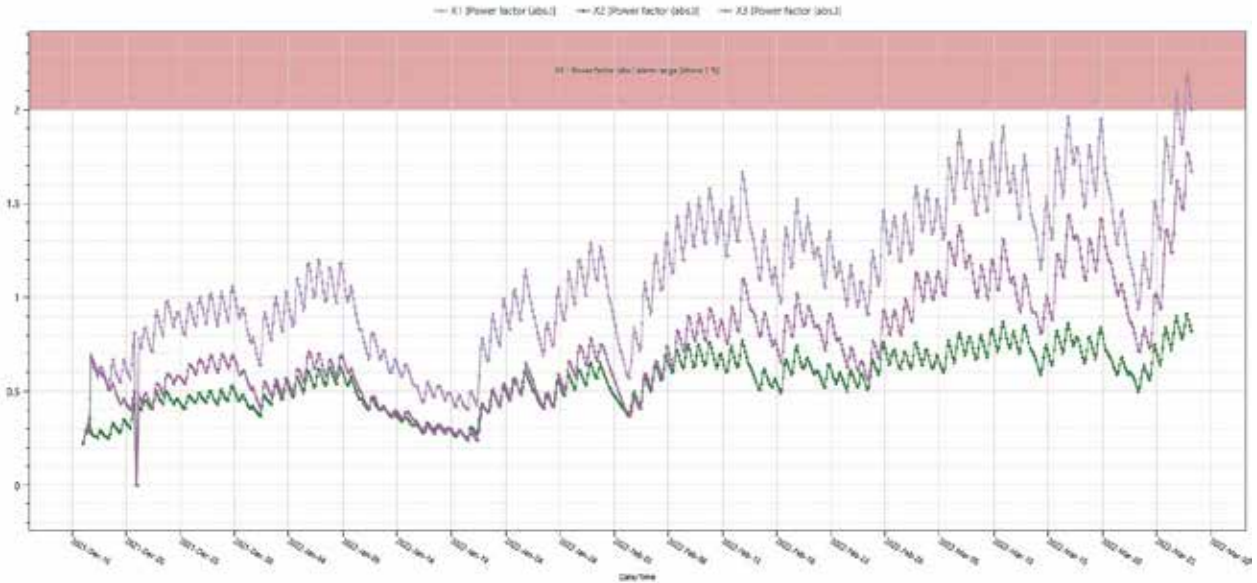
One-year plot of low-side bushing power factor shows dangerous trend toward failure. (Courtesy: ZTZ Services International)

Transformers used for solar sites between the inverters and the utility transmission line see rough service. Daily full-on, full-off along with the effects of transients and harmonics is not normal substation transformer duty. Since the power factor of a bushing is affected by heat, the daily cycle shows in the power-factor plot. A monitor recently logged this data at a large solar facility in California. It clearly shows the effect of temperature as a saw-tooth pattern but also that two of three bushings on the low side are developing internal problems, causing the overall power factor to trend higher, X3 rising to alarm level with X1 not far behind.

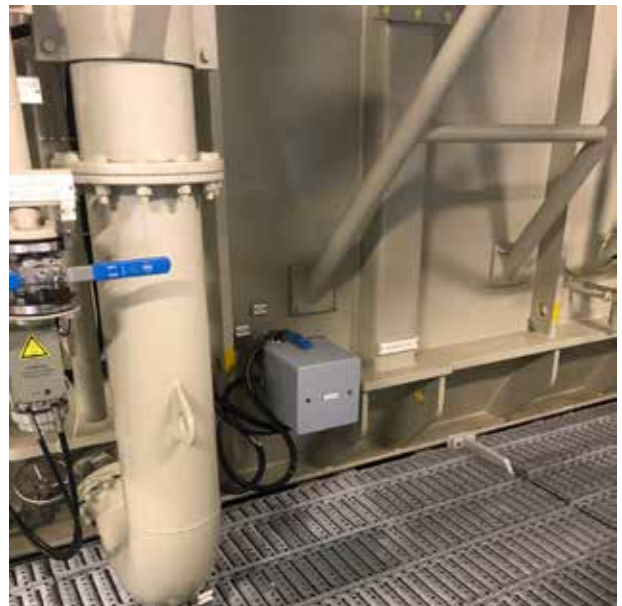
An on-line DGA system installed at Hornsea II offshore wind. (Courtesy: ZTZ Services International)

As a retrofit device, the DGA is simply mounted directly onto the drain valve. DGA systems are available from “early warning,” which look for hydrogen, moisture, and a composite value of hydrocarbons, to a full-range of 10
