MONITORING ROTATING MACHINERY

Keeping an eye on the health of your wind turbine rotating machinery via condition monitoring will help avoid costly downtime and expensive repairs. Romax Technology explains.

By Dr. Ashley Crowther and Dr. Tugan Eritenel

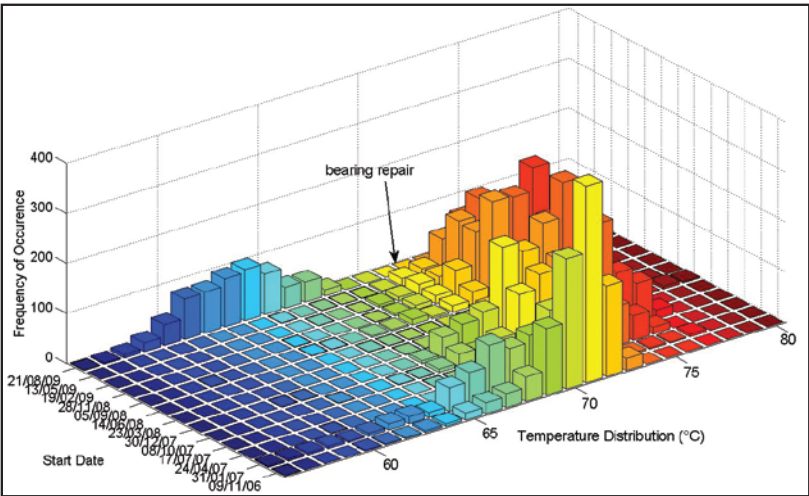
Fig. 1: Gearbox bearing temperature across wind farm.

Temperature trending is easy to do. Every modern turbine SCADA system records 10-minute temperature data for the gearbox oil and several bearings, mainshaft bearings, generator bearings, and various other locations such as pitch motor temperatures and generator winding temperatures. Temperature can provide a good indication of a problem (see fig. 1), which provides the distribution of temperature each week. The bearing showed a clear trend of overheating; the replacement was scheduled two months out when mean temperatures approached 75°C and the damage was approaching a critical stage (fig. 2).

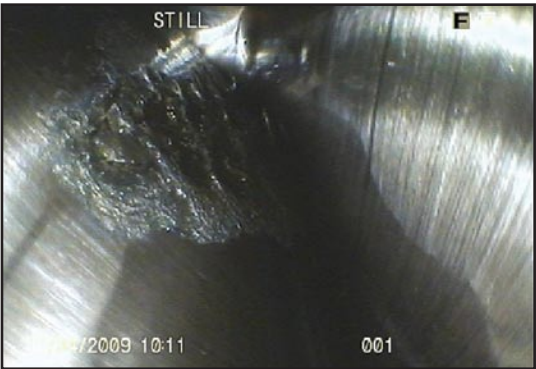
Fig. 2: Bearing suffering from macropitting leading to increases in temperature and vibration.

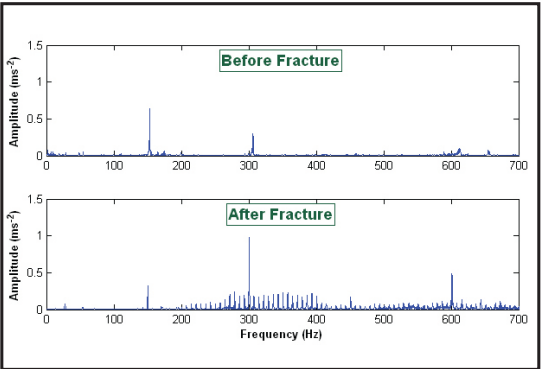
Fig. 3: Gearbox envelope spectra before/after gear tooth fracture.

Yet not all damage is obvious, or the trend slow. For example, if inclusions are present in the gear material the fatigue crack origin is likely to be subsurface, and cracking may propagate along the tooth axially some distance before reaching the surface, at which point a large tooth segment may be quickly liberated. This

is a catastrophic failure that requires immediate shut down. Detecting such damage should not be difficult. The RMS (root mean square value of the vibration level) will increase rapidly, and the envelope spectra (a demodulated vibration signal) will show an obvious issue. Figure 3 provides an easy “spot the difference” example.

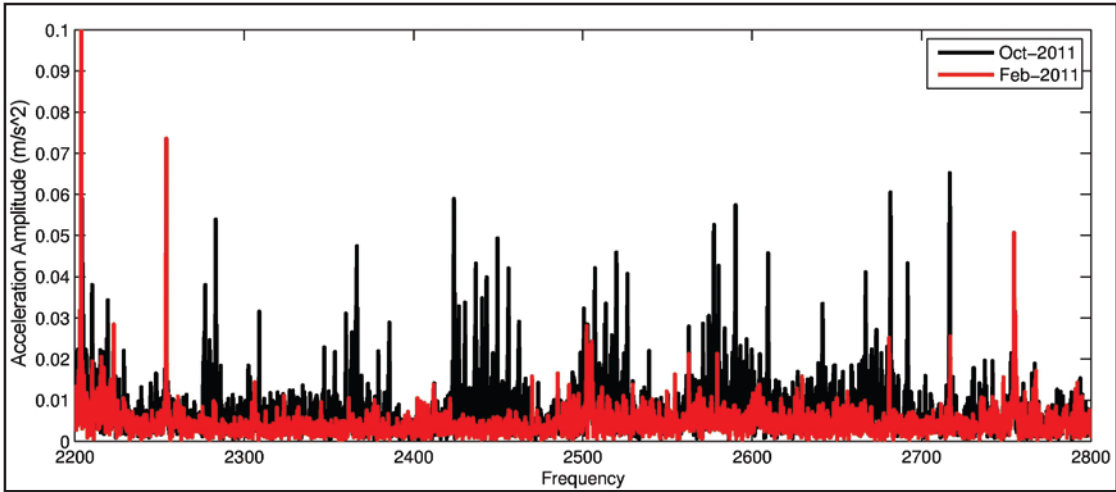
Fig. 4: Acceleration frequency spectrum for wind turbine in February and October. The increased response is from bearing axial crack. The vibration signal is from a gearbox accelerometer.

An axial crack forming in a wind turbine bearing raceway is actually similar to the type of controlled experiment performed in research laboratories, where a raceway or roller has a line defect machined for production of a clear repetitive impulse. The crack will cause a sharp impulse when it passes through the bearing contact zone, exciting the structural system in a similar fashion to a modal test. The impulse will excite natural frequencies of the structure that are detected at the various vibration sensor locations, depending on the transfer function between impulse location and sensor. The natural frequencies become a carrier frequency, and when the envelope analysis technique is applied the signal is demodulated to pro-

vide the frequency of the defect. Figure 4 shows the frequency spectra for a bearing that has developed such a crack and the marked change in the frequency spectra.

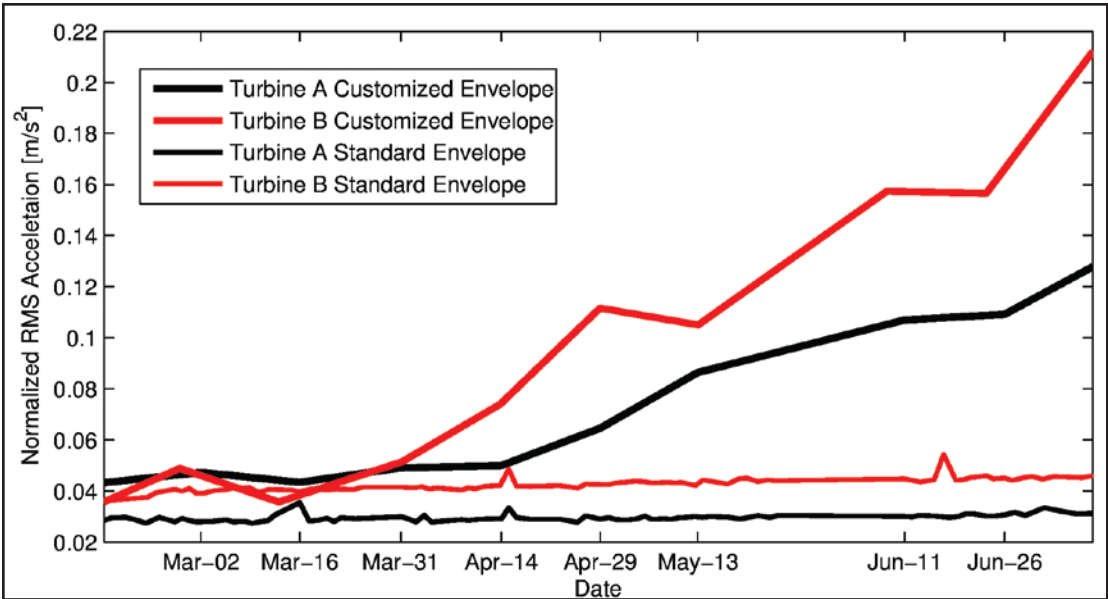
Fig. 5: Envelope analysis of the acceleration signal for wind turbine in February, August, and October. Dashed lines indicate bearing inner race crack frequencies with harmonics.

eters, yet they don't necessarily band pass the appropriate carrier frequency to detect the crack. Figure 5 illustrates this, with the RMS of a standard envelope (and RMS) from installed CMS compared to an envelope technique customized by Romax to find cracks occurring at this particular wind farm. In this case

temperature data also showed no evidence of the crack formation and growth.

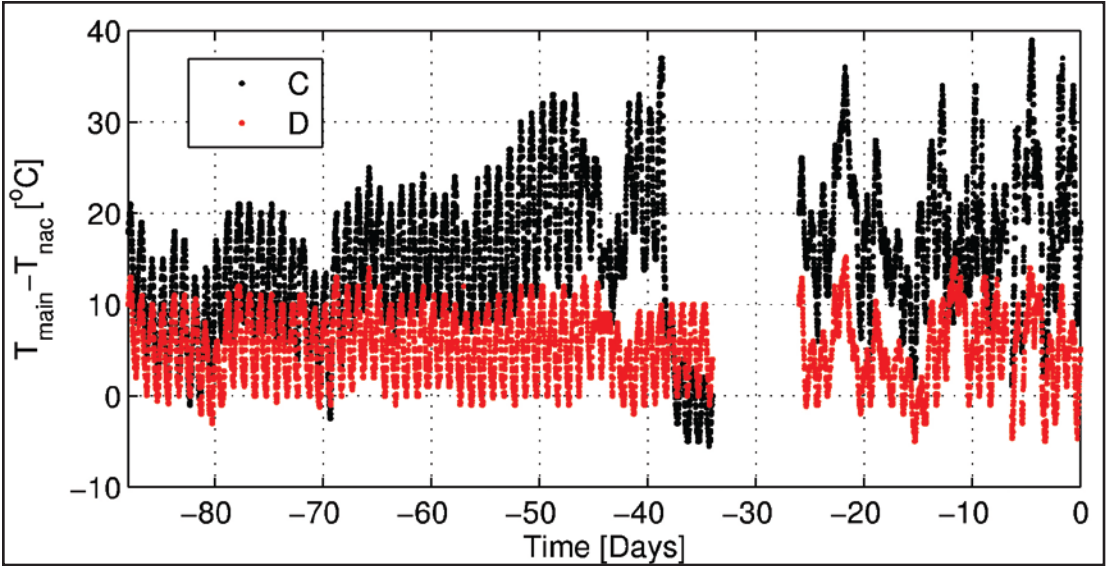
Fig. 6: Temperature trend for turbines A and B.

common failure mode can be six to nine months in development from initial damage to a critical state. Figures 6-8 provide temperature and vibration examples for a group of the turbines (note that the days on the graphs correspond). Here several bearings at the site are failing, yet temperature trends are only clear in one machine, where the damage is severe. A combination of several vibration techniques in-

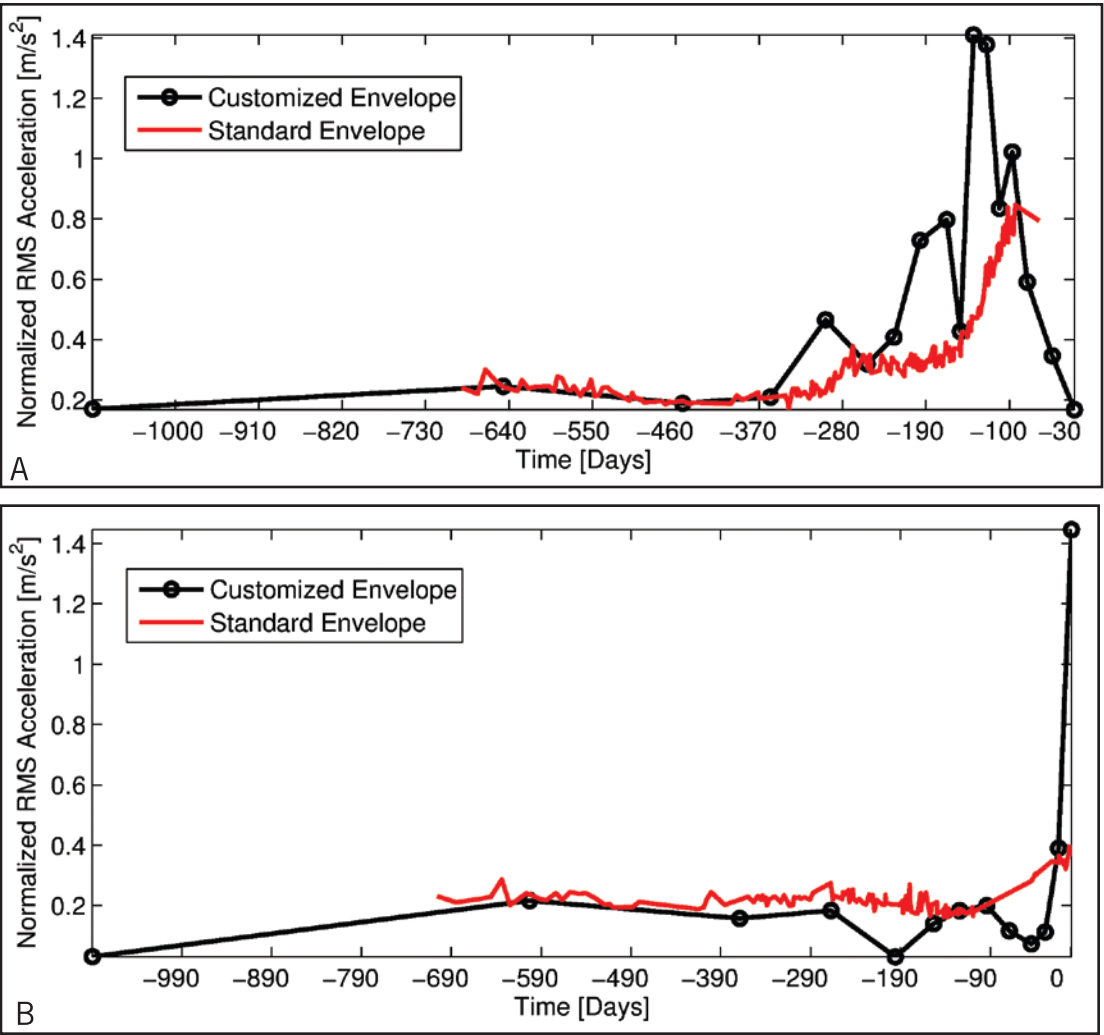
Fig. 7: Vibration trend of (a) turbine A and (b) turbine B. RMS values are normalized for easy comparison.

cluding customized envelopes and trending fault frequencies as well as certain envelope bands does yield good results. Once a certain level of damage is reached, the bearing defect trends can decrease (fig. 7). This is a sign that the damage has progressed from isolated areas to a large proportion of the raceways and rollers, as was the case when the bearing was inspected at day 0. The customized envelope is pro-

viding a much earlier and clearer indication of damage, and the temperature trend only provides a late indication. See fig. 8 for an image of the condition of the main bearing for Turbine A at -128 days, and fig. 9 during teardown inspection by Romax engineers.

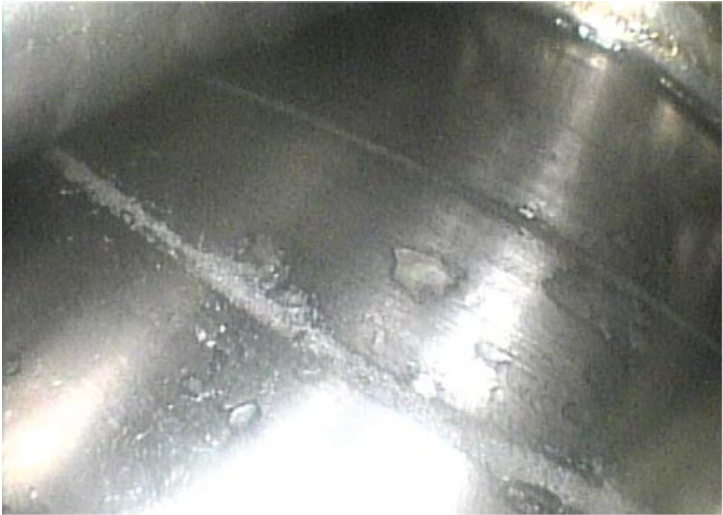
Fig. 8: Turbine A main bearing condition at -128 days.

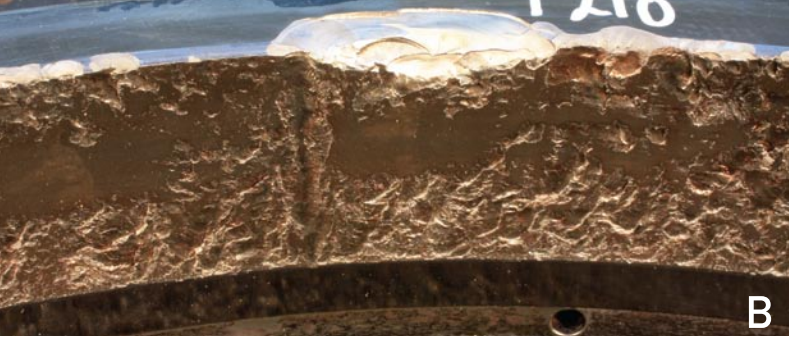
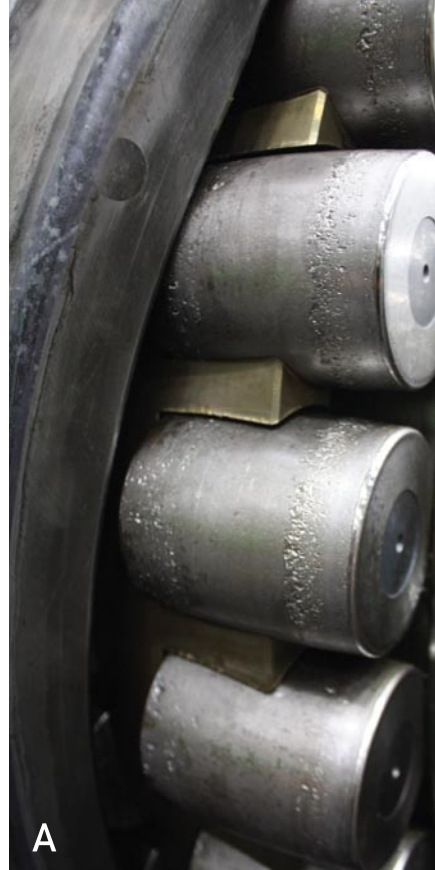
Fig. 9: Turbine A main bearing condition at RCA teardown inspection (a) showing outer race compression (b).
