ROTOR BLADE LEADING EDGE EROSION – REAL LIFE EXPERIENCES

When leading edge erosion is not repaired or is repaired incorrectly, the health of the blade and the turbine is jeopardized.

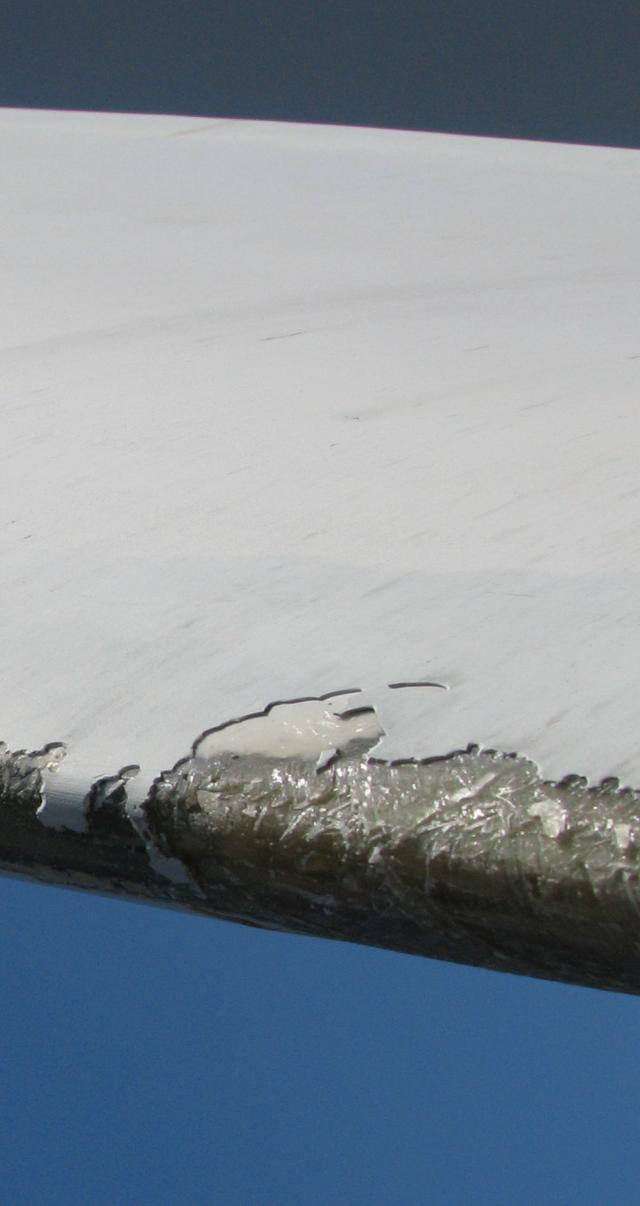
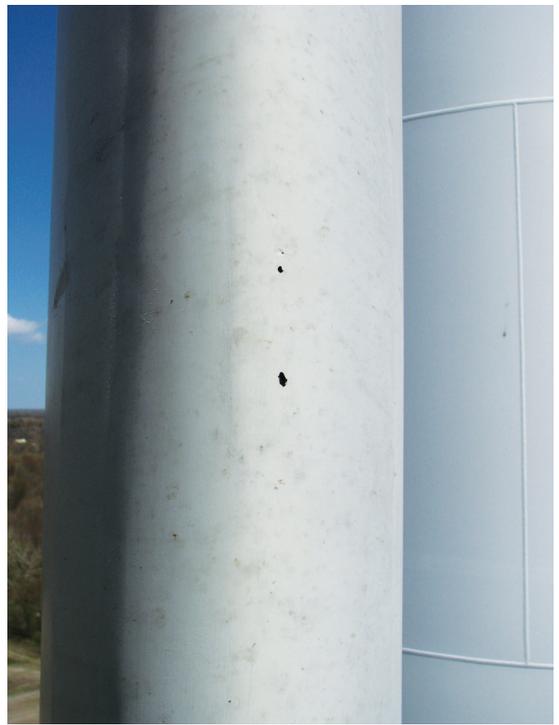
As the name suggests, the leading edge of a blade is the foremost edge of the airfoil or the part of the blade that first contacts air. Any turbine located in terrain that has an abundance of dust, bugs, rain, sleet, snow or any other abrasive air particulate is more susceptible to erosion than a turbine located

Unfortunately, leading edge erosion begins early in the life of a blade. If leading edge protection has not been applied during the manufacturing process, blades as young as three years old will begin to show signs of wear. The tip of the blade is more susceptible to wear due to the operating speed of the blade at the tip; however, erosion does present itself inboard of the tip at this stage as well. Even if leading edge protection has been applied, quality issues, perceived as minor in the factory, also play a role in the rate at which a leading edge degenerates. Small air pockets along the leading edge are routinely overlooked and covered up with coating. As the blade bends and flexes, these air pockets expand and contract causing the leading edge to erode from the interior of the coating.

Simultaneously, external debris causes deterioration on the leading edge from the exterior. When erosion is identified in the early stage, repair is relatively inexpensive when compared to waiting until more severe coating damage appears. If repairs are not done early, damage to the underlying laminate will be present as early as year five. Regrettably, there remains a large gap in the knowledge and experience of those performing rotor blade repairs, and often the wrong choice of materials is used to repair laminate damage. Generally, cost is the driving factor when improper materials and an insufficient repair program are chosen. Although the cost of repair is much lower, a repair using incorrect materials will only mask the damage for a short period of time before a compounded problem returns.

When leading edge erosion is not repaired or is repaired incorrectly, the health of the blade and the turbine is jeopardized. Vibrations create undesirable loads that neither the turbine nor the blades were designed to carry. Chordwise and spanwise cracks in the blade coating occur. A blade shell is made of a
