ARE TRANSIENT EVENTS DAMAGING YOUR TURBINE'S DRIVETRAIN?

Searching for the root causes of White Etch Area damage and other failure modes.

By Doug Herr and Dave Heidenreich

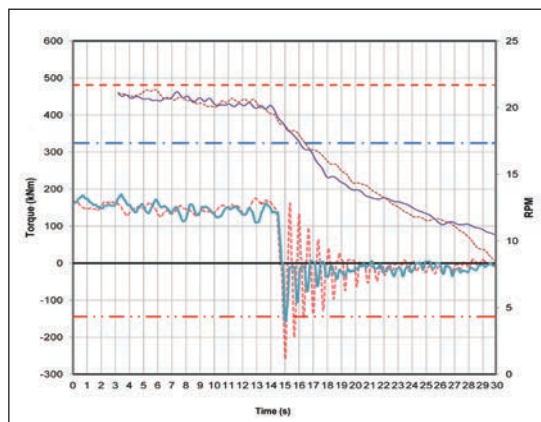
Figure 1

This plot shows the results of a normal braking event on this turbine. The aero-tips have deployed while the turbine is operating under partial power.

- Black line is zero torque
- Red line is actual torque
- Dashed blue line is nominal torque.
- Dashed red lines are standard torque limiter settings

When the aero brake engages, the torque spikes in the negative direction, causing the system to wind up and unwind back and forth in the reverse and forward directions. Each time the torque crosses the black zero line, the load zone on every bearing in the gearbox shifts approximately 180 degrees in the opposite direction. In this instance, it occurs 11 times.

Many plots similar to the one you see here were recorded, in all types of wind conditions. Surprisingly, even when the turbine power was minimal at the time of the aero braking event, similar transient reverse torque loads were experienced by the gearbox and drive system.

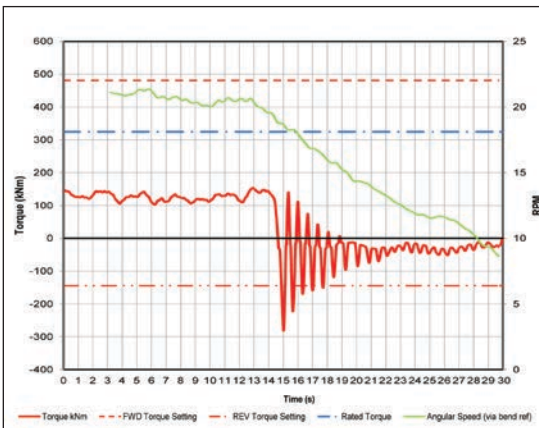
The WindTM monitor was magnetically mounted to the main shaft of the turbine, allowing for quick installation and removal. The on-shaft unit communicated to a transceiver that allowed remote access to the data accumulated via cellular network. Strain gauges on the main shaft measured both torsion and bending. The cycling rate of the bending load in the shaft provided a measurement of the speed. The monitoring unit continuously fed the data into a buffer.

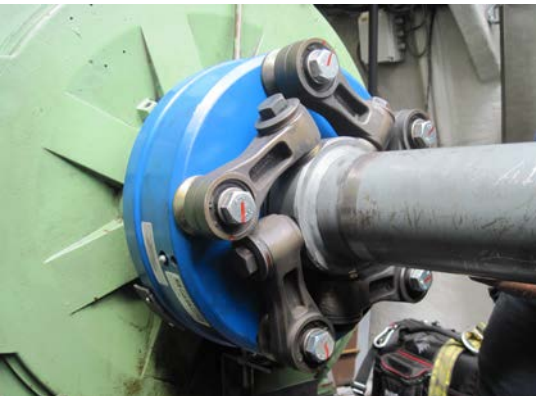
The WindTC is the first torque limiter with asymmetric, independent settings for forward and reverse torques in a drivetrain. Standard torque limiters used in some wind turbines have one setting, usually 150–180 percent of nominal turbine torque. This limits only very large transient torque spikes in both directions. Drivetrains are designed to handle these loads in the forward direction. JR Dynamics has instrumented the rollers in gearbox bearings on other wind turbines and found that during torque reversals the rollers in the bearings are skewed when these reversals occur. This causes concentrated loading of the rollers and damage to the rollers and races (to see

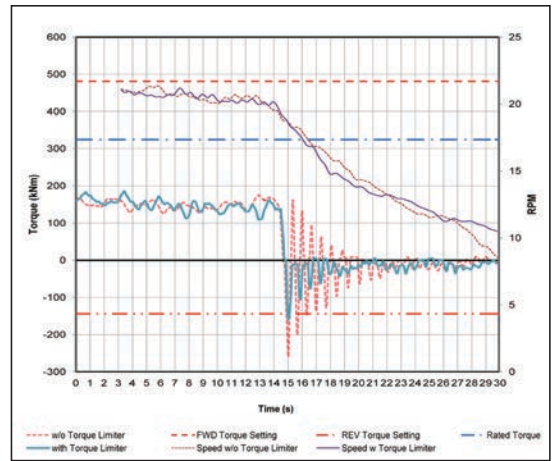
Figure 2

This data plot (Figure 2) is a representative sample of many collected over several months, comparing the

actual torque loads in the turbine drive systems with and without the WindTC.

This plot shows the results of a normal braking event on two turbines, one with the WindTC (blue solid line) and one without (red dotted line). The aero-tips have deployed while the turbines are operating under partial power.

- Black line is zero torque
- Solid blue line is the torque with the WindTC

- Red dotted line is torque without the WindTC
- Dashed blue line is nominal torque
- Dashed red lines are standard torque limiter settings
- Dashed maroon and purple lines show low-speed shaft speed

Without the WindTC, (dotted red), there is a large uncontrolled torque reversal at 75 percent of nominal turbine rating followed by a series of torque reversals back and forth over the zero torque line. The turbine equipped with a WindTC, from PT Tech (solid blue line), shows the initial reverse torque spike being absorbed at 40 percent of the nominal turbine rating. More importantly, the slight reverse torque slippage in the WindTC dampens the torsional vibration so effectively that no additional reversals are recorded.

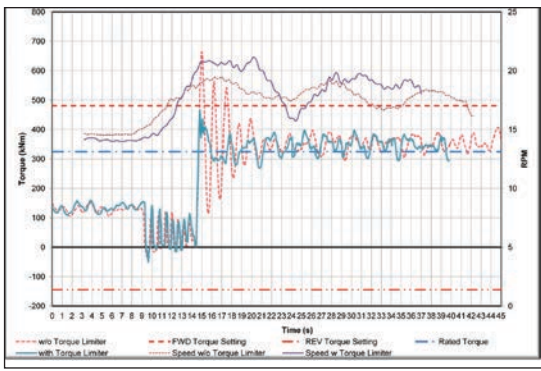
Figure 3

Forward Slip Torque Event: The NEG Micon NM 48 is a two-speed turbine that is not equipped with any torque limiting device. This plot (Figure 3) shows the comparison during an upshift event of the two turbines. The generators are operating at low speed. As wind speed increases, the low speed generators are disengaged, and the wind turbine speeds up as the high speed generators contactors engage.

- Black line is zero torque
- Solid blue line is the torque with the WindTC
- Red dotted line is torque without the WindTC
- Dashed blue line is nominal torque
- Dashed red lines are standard torque limiter settings
- Dashed maroon and purple lines show low-speed shaft

The turbine without the WindTC protection sees a torque spike of 200 percent when changing from one set of contactors to another. The turbine with the WindTC is protected from this spike at its 150 percent setting and also prevents significant additional oscillations that are potentially damaging, even though they don't cross the zero torque line.

The WindTC also provided torque protection in the forward direction. During Phase II, some up-shifting events on the unprotected turbine resulted in 200 percent forward torque overloads. The turbine with the WindTC during the same event had forward torque overloads effectively limited to 150 percent of rated turbine torque.

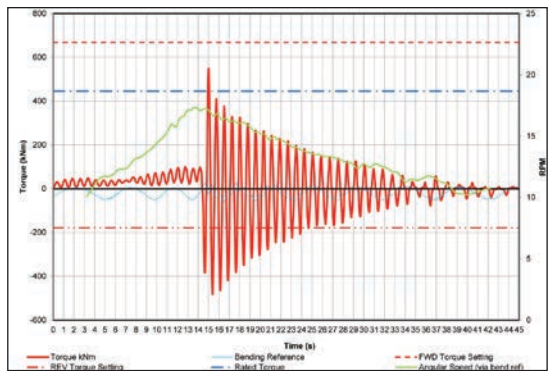
Figure 4: Nordex N54 – 1 MW Braking event

Larger, more current generation wind turbines up to 2MW have been monitored in the field with the same methods and have shown dramatic torsional reversals during transient events (Figures 4 and 5). Blade pitch systems reduce braking shock load events but damage still occurs with sudden curtailments and e-stops. These events are much less common but they are significantly larger in impact due to the increased size of the turbine's rotor and generator.

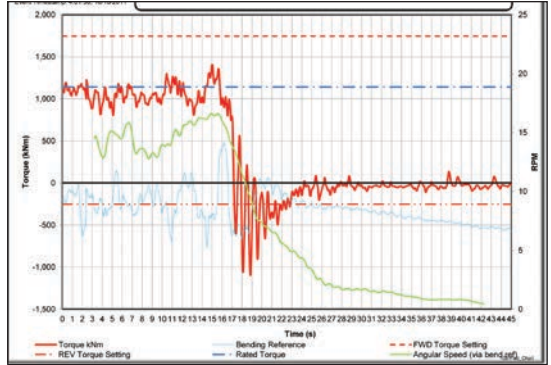
Figure 5: Gamesa G87 – 2 MW High Wind Shutdown
