WHITE STRUCTURE FLAKING IN ROLLING BEARINGS FOR WIND TURBINE GEARBOXES

By Hideyuki Uyama and Hiroki Yamada, NSK Ltd.

An investigation into the failure modes yielding white structure flaking and axial cracking in wind turbine gearbox rolling bearings

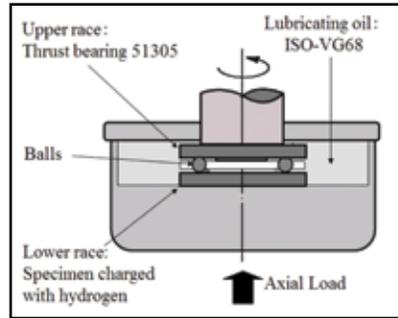
Figure 4: Schematic of the thrust type rolling contact fatigue test machine

The specimens were immediately assembled into the thrust bearing test machine after having been charged with hydrogen as shown in Figure 4. The upper race was a 51305 thrust bearing ring and the lower race was the specimen mentioned above. The rolling elements were 6 balls with a diameter of 9.525 mm. The retainer used was made of brass. The lubricating oil used was ISO-VG68. The maximum contact pressure was 3.8 GPa and the rotating speed was 1000 min⁻¹.

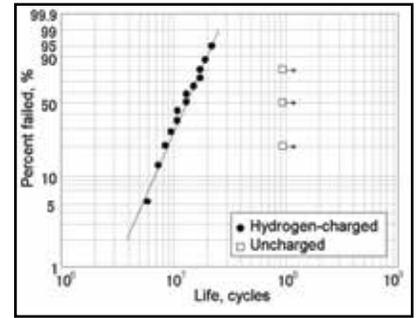
Figure 5: The results of thrust type rolling contact fatigue tests

Figure 5 shows the result of thrust type rolling contact fatigue tests using the hydrogen-charged specimen and uncharged specimen. Flaking occurred in the hydrogen-charged specimens, and the rolling contact fatigue life was much shorter than in the uncharged specimen.

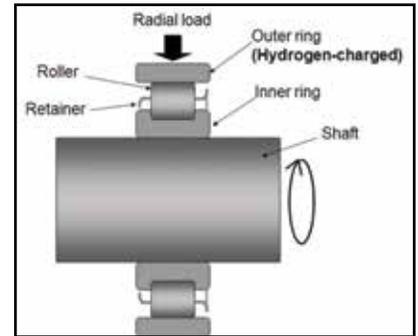
Figure 7: A schematic of radial type bearing test machine

Cylindrical roller bearings are used for the experiment to reproduce the axial cracks, because they are often used for wind turbine gearboxes and the axial cracks have not been seen in ball bearings. Although, white structure flaking has been observed in ball bearings. Bearing number of N308 made of JIS-SUJ2 bearing steel, equivalent to SAE 52100, were used as the test bearings with a bore diameter of 40 mm and an outside diameter of 90 mm. Only the outer ring was separated and charged with hydrogen by the same method mentioned previously and the inner ring and the rollers were uncharged, and then the test bearing was set on the radial type bearing test machine as shown in Figure 7.

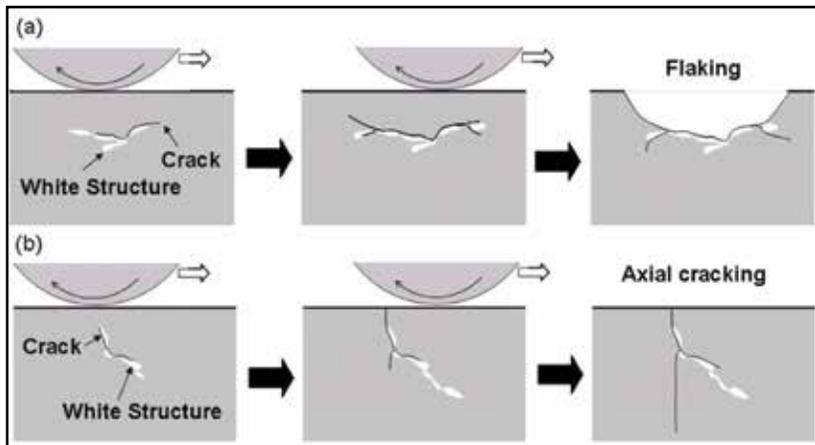
Figure 10: Schematics of the failure process of white structure flaking and axial cracking a) The case of flaking b) The case of axial cracking

Failure mode of the axial cracks is very unique and is seldom seen in other applications except for wind turbine gearboxes. However, it seems that the hydrogen-charge method does reproduce it. This method is very simple and the other effects on rolling contact fatigue are small. Therefore, it is supposed that axial cracks seen in wind turbine gearbox bearings are also caused by hydrogen. The patterns of white structure due to hydrogen are random, so that cracks along the white structure can propagate in various directions. It is supposed that some cracks mainly propagate in a horizontal direction to the rolling elements' translational direction and finally cause flaking, and that other cracks mainly grow in the vertical direction to the rolling element's translational direction and results in the axial cracks on the raceway surface as shown in Figure 10.

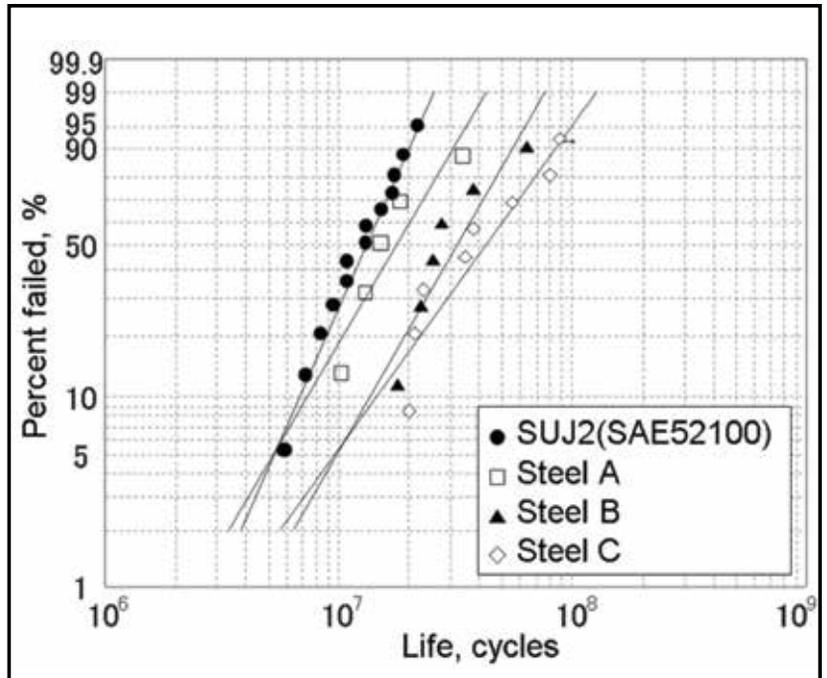
Figure 11: The effect of the chemical composition of steel on white structure flaking life

Figure 11 shows the result of a rolling contact fatigue test using the flat disk specimens charged with hydrogen and the thrust type rolling contact fatigue test machine in the same way as shown in Fig. 4. Four kinds of steels were used for the specimens; JIS-SUJ2 equivalent to SAE52100, steel A, B and C. Chemical compositions were different in them; steel A contains more Mn, steel B contains more Si and steel C contains more Cr. Rolling contact fatigue life of steel A, B and C were extended comparing to JIS- SUJ2. This result suggests that white structure flaking life can be extended by improvement of chemical composition of steel and it can delay formation of the white structure.

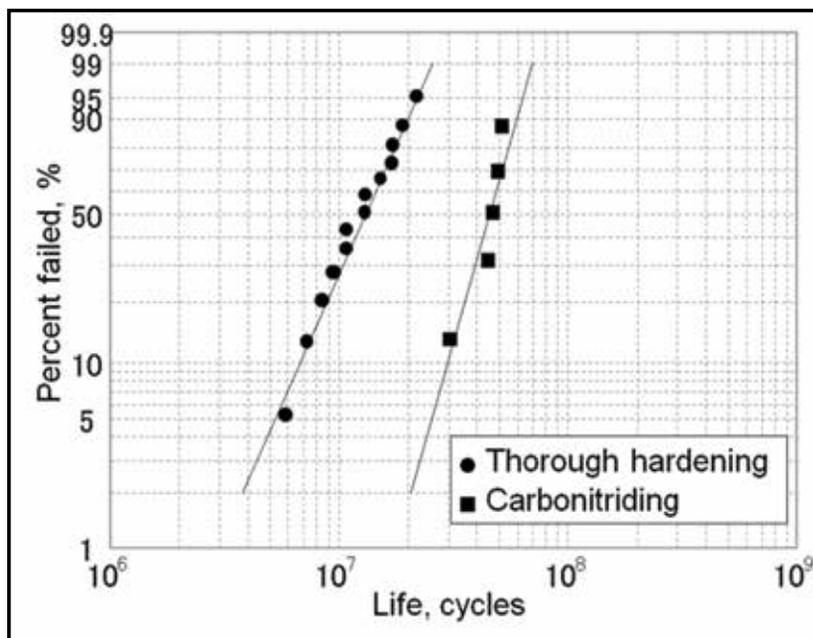
Figure 12: The effect of heat treatment on the white structure flaking life.
