# WIND TURBINE DFIG GENERATOR SLIP RING DEFECT

*This case study shows how, in time, detection of slip ring defects could result in fast and non-expensive repairs.*

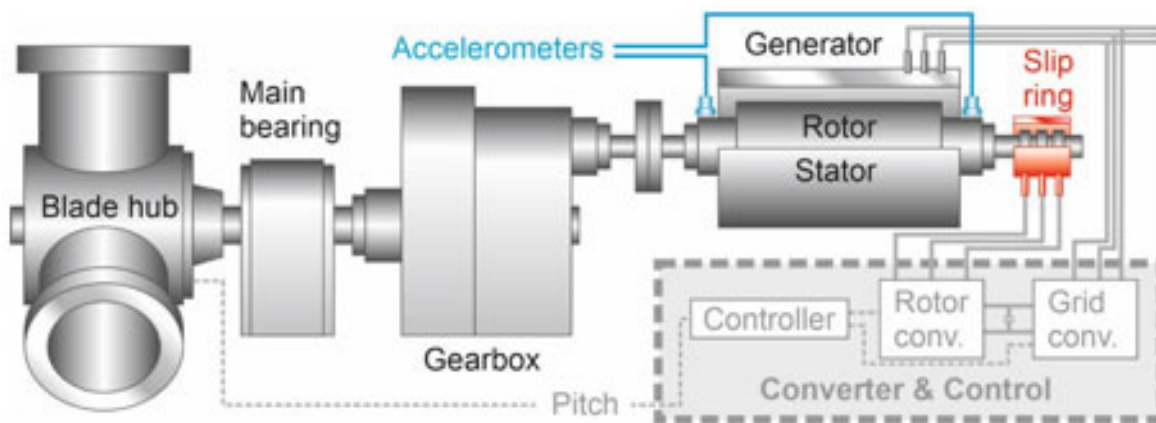
Condition monitoring of wind-turbine generators is performed based on vibration data collected from accelerometers mounted in the load zone of drive end (DE) and non-drive end (NDE) bearings of the generator. A number of generator faults can be detected by these accelerometers, including faults with the slip ring assembly.

Figure 1: Location of the DFIG generator slip ring assembly and the vibration sensors on the generator bearing housing for monitoring the slip rings.
