RE-POWERING & GEARBOXES

# PERFORMANCE ENHANCEMENT IN WIND TURBINE MAIN SHAFTS USING SURFACE COATING TECHNIQUES

*Thermal spray and laser cladding coating methods offer strong potential to enhance the performance of main shafts, provided that additive process parameters are rigorously validated and controlled.*

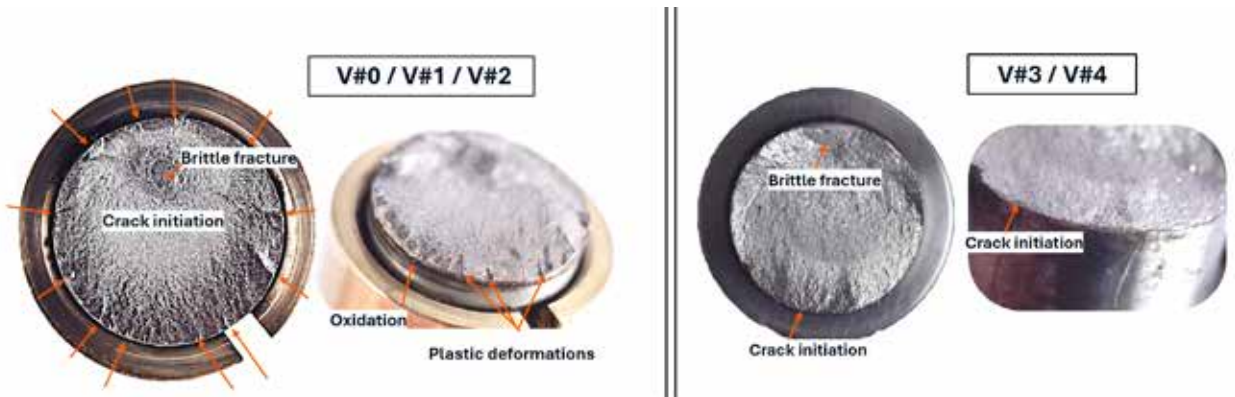
Figure 6: Failure morphology differences between metal & laser coatings.

Failure morphology varies by coating type. In uncoated and thermal-spray-coated specimens (V#0, V#1, V#2), fractures originated at the surface. In contrast, in laser-cladded specimens (V#3, V#4), failures initiated below the surface within the heat-affected zone (Figure 6).

For uncoated specimens (V#0) and those with metal spray (V#1, V#2), fractures were located at the bearing interface. The origin was linked to fretting, with localized oxidation and plastic deformation generating oblique micro-cracks from which fatigue cracks propagated. These nucleation points appeared around the full specimen circumference. After nucleation, cracks propagated with smooth textures and beach marks, and the final rupture occurred through brittle overload, visible as a rough and shiny surface.

In laser-cladded specimens (V#3, V#4), fractures originated 2-4 mm beneath the surface, likely in the heat-affected zone. Crack initiation was con-

centrated in a region opposite the brittle overload fracture zone. Fatigue cracks then propagated until final brittle overload failure occurred.
