O&M: MAINTENANCE ▸ CONDITION MONITORING

WINDING DOWN MAINTENANCE COSTS

Why electroplating can be crucial to keeping wind-turbine generator repair costs down.

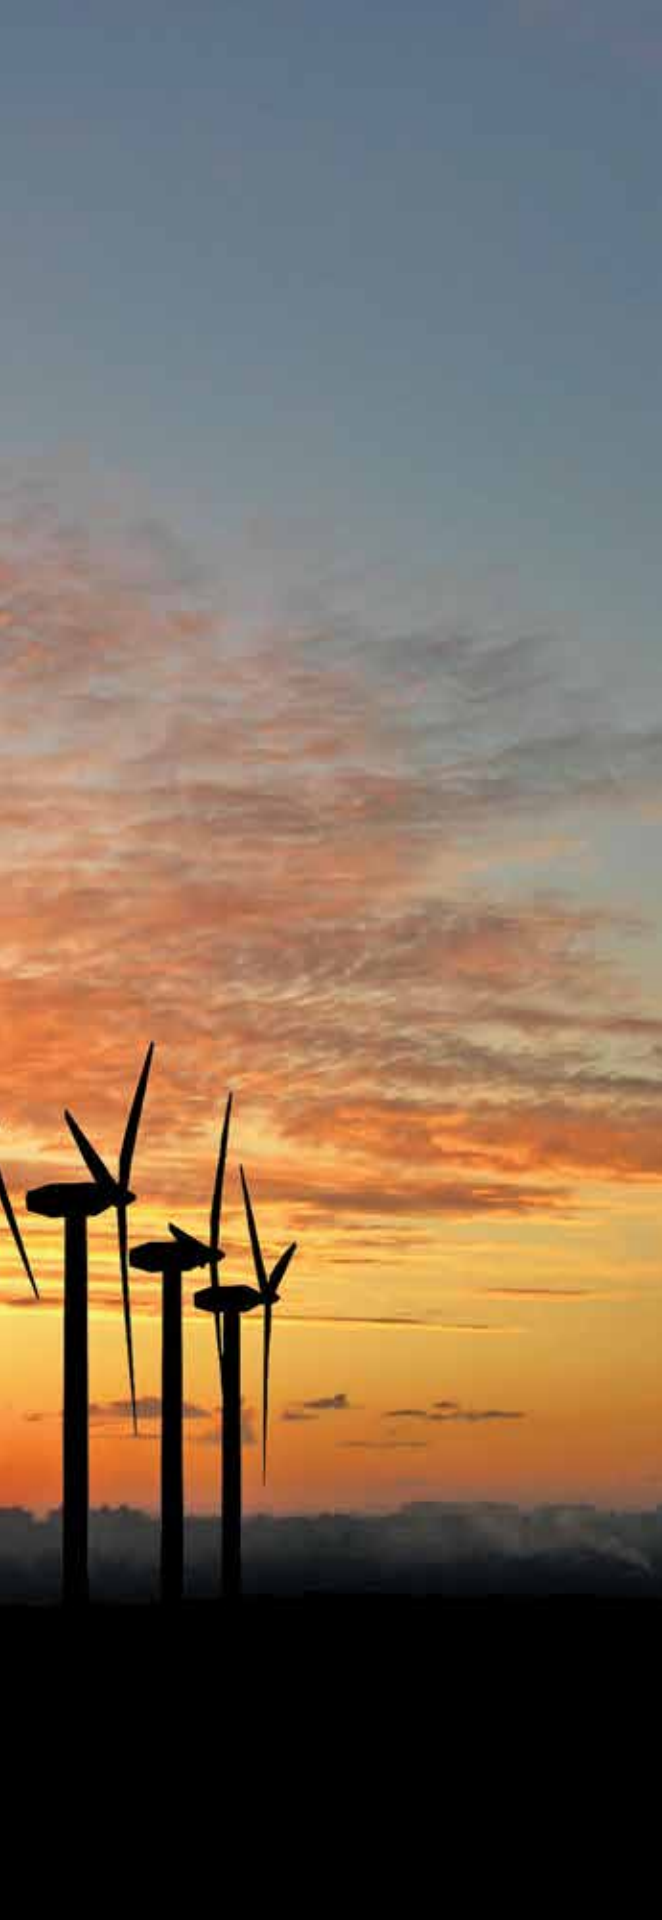
In wind-turbine generators, wear often occurs in the rotating parts of the machine.
(Courtesy: SIFCO ASC)

In wind-turbine generators — or any generators or rotating machinery for that matter — wear often occurs in the rotating parts of the machine. In the specific example of bearing seats, over time the seat and the bearing ring can wear due to creep and/or fretting. They also can deteriorate from corrosive substances in the air, for example sea salt on offshore wind farms.

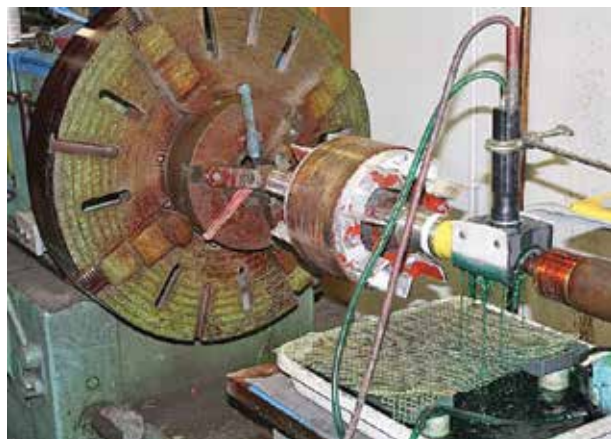
Brush plating presents operators with the answer to two common wear issues seen in wind-turbine generators, bearing seat damage, and slip ring wear. (Courtesy: SIFCO ASC)

Brush plating presents operators with the answer to two common wear issues seen in wind-turbine generators, bearing seat damage, and slip ring wear. By being able to repair and build the thickness of these components back to specification in a fast and economical way, they become longer lasting, and capital outlay is reduced by not having to replace parts.

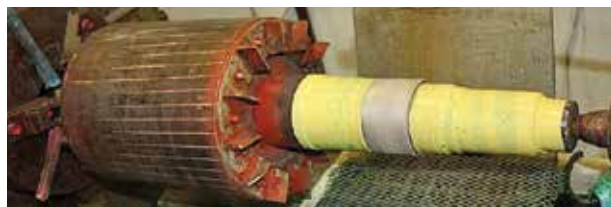
Brush plating equipment is small, lightweight, and portable. (Courtesy: SIFCO ASC)

Brush plating equipment is small, lightweight, and portable. This allows the process to come to the part, eliminating the need to ship a large part to a specialist plating house. This saves time and shipping cost, which with the typical size of components in the power generation industry, can be significant. SIFCO ASC has even performed up-tower repairs. When talking about generator components, in most cases they are usually too large to fit into a tank typically used for tank plating, thus eliminating tank plating as an option altogether.
